REPORT NUMBER: NCAP-MGA-2007-008

**NEW CAR ASSESSMENT PROGRAM
FRONTAL BARRIER IMPACT TEST**

**DAIMLERCHRYSLER CORPORATION
2007 JEEP WRANGLER
NHTSA NUMBER: M70303**

**PREPARED BY:
MGA RESEARCH CORPORATION
5000 WARREN ROAD
BURLINGTON, WI 53105**

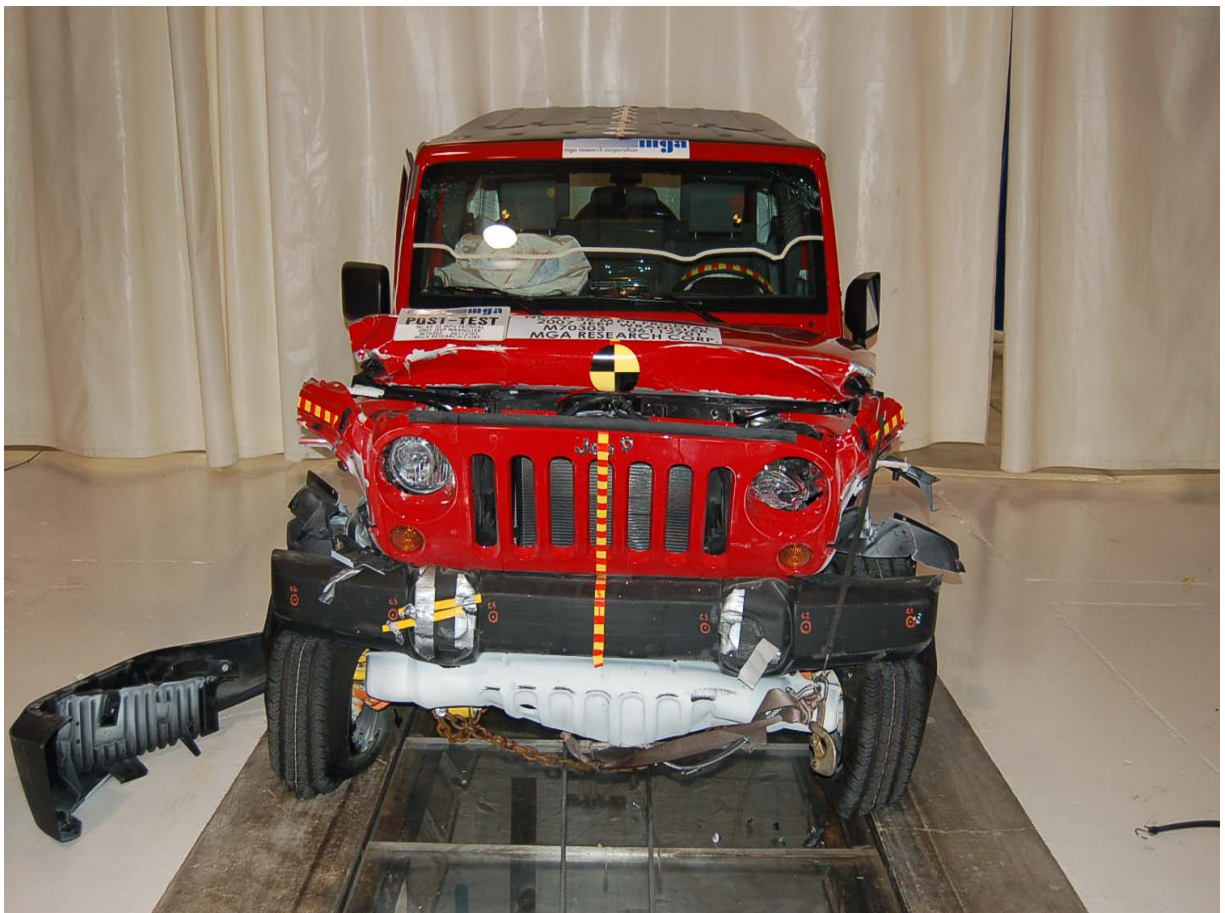
Post-Test Front View

The maximum static crush of the vehicle was 465 mm and both the driver and passenger side doors remained closed and latched during the impact event and were operable after the impact.

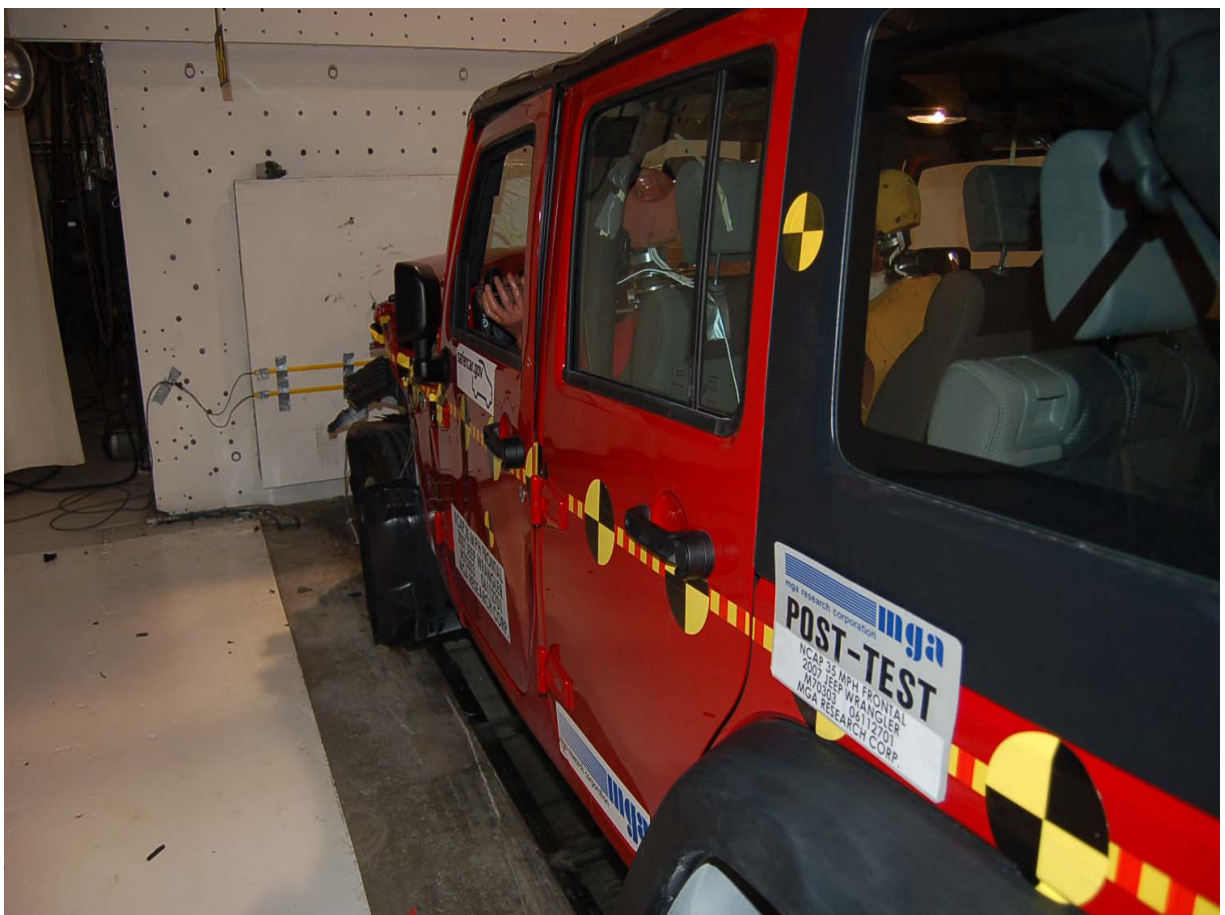
Post-Test Left Side ¾ View of Doors After Impact

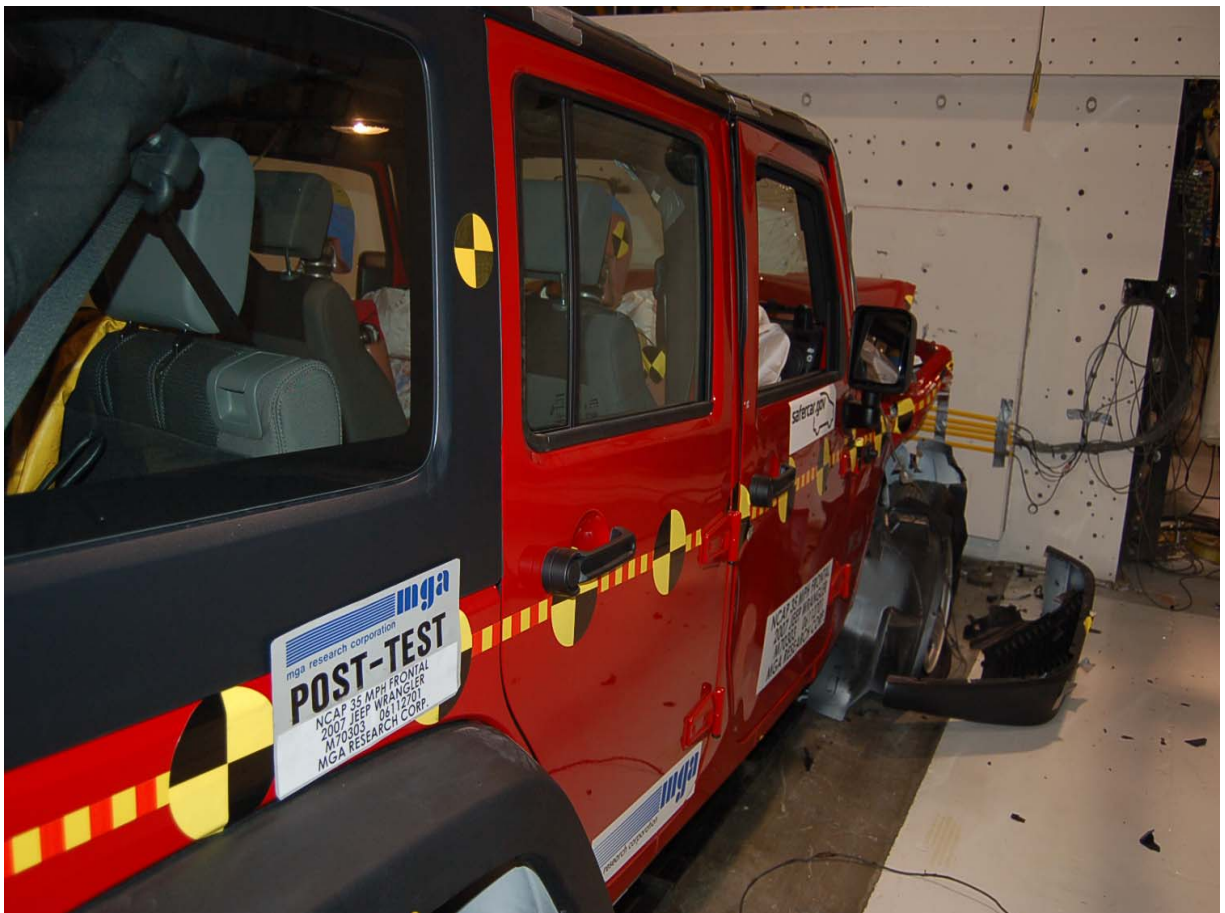
Post-Test Right Side ¾ View of Doors After Impact

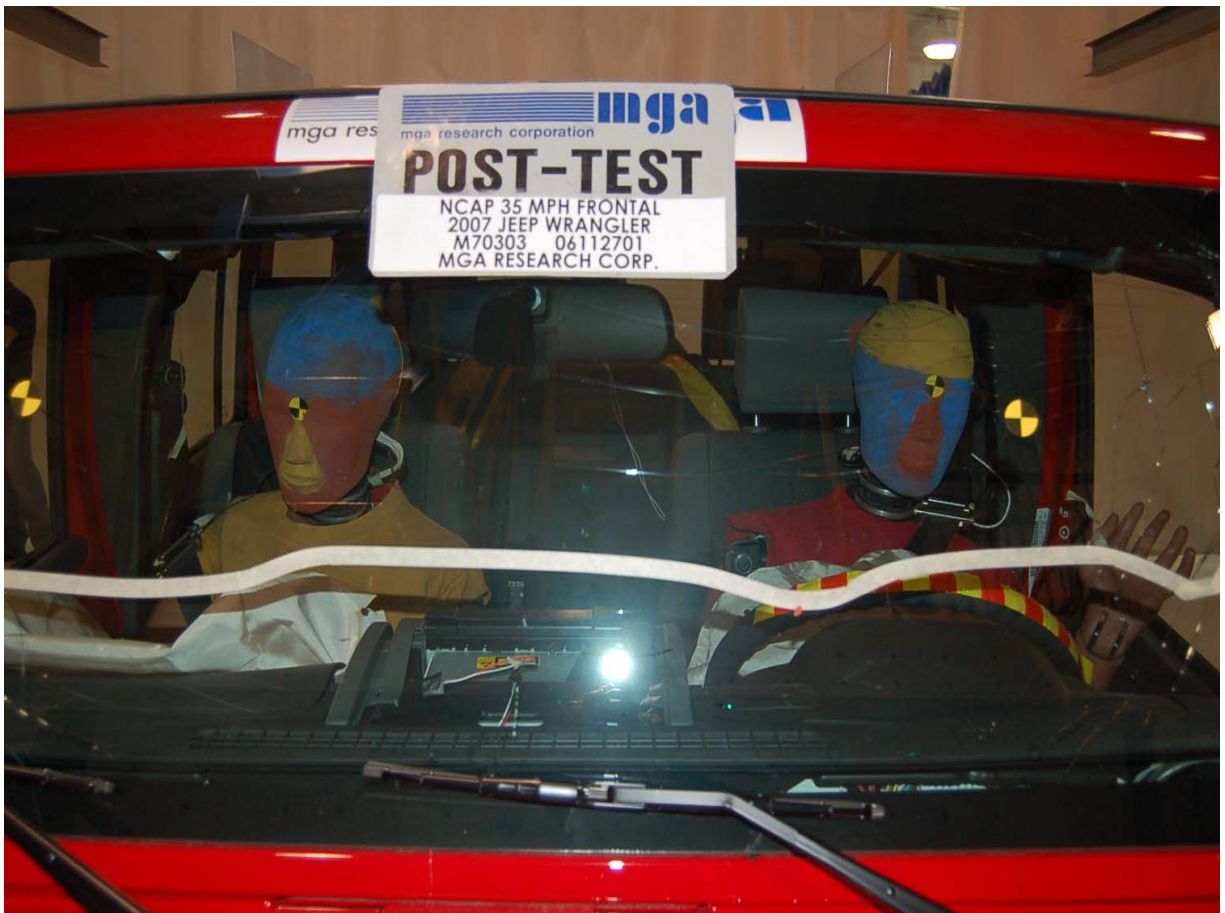
Post-Test Windshield View

There was 100 percent windshield retention and no intrusion into the protected zone of the windshield during the event. There was no Stoddard Solvent leakage after the event or during any phase of the static rollover.

Description	Driver	Passenger
Locked/Unlocked Doors	Doors were unlocked	Doors were unlocked
Front Door Opening	Door remained closed and latched; Door opened without tools	Door remained closed and latched; Door opened without tools
Rear Door Opening	Door remained closed and latched; Door opened without tools	Door remained closed and latched; Door opened without tools
Seat Track Shift (mm)	0	0
Seat Back Failure	None	None
Glazing Damage	The windshield cracked.

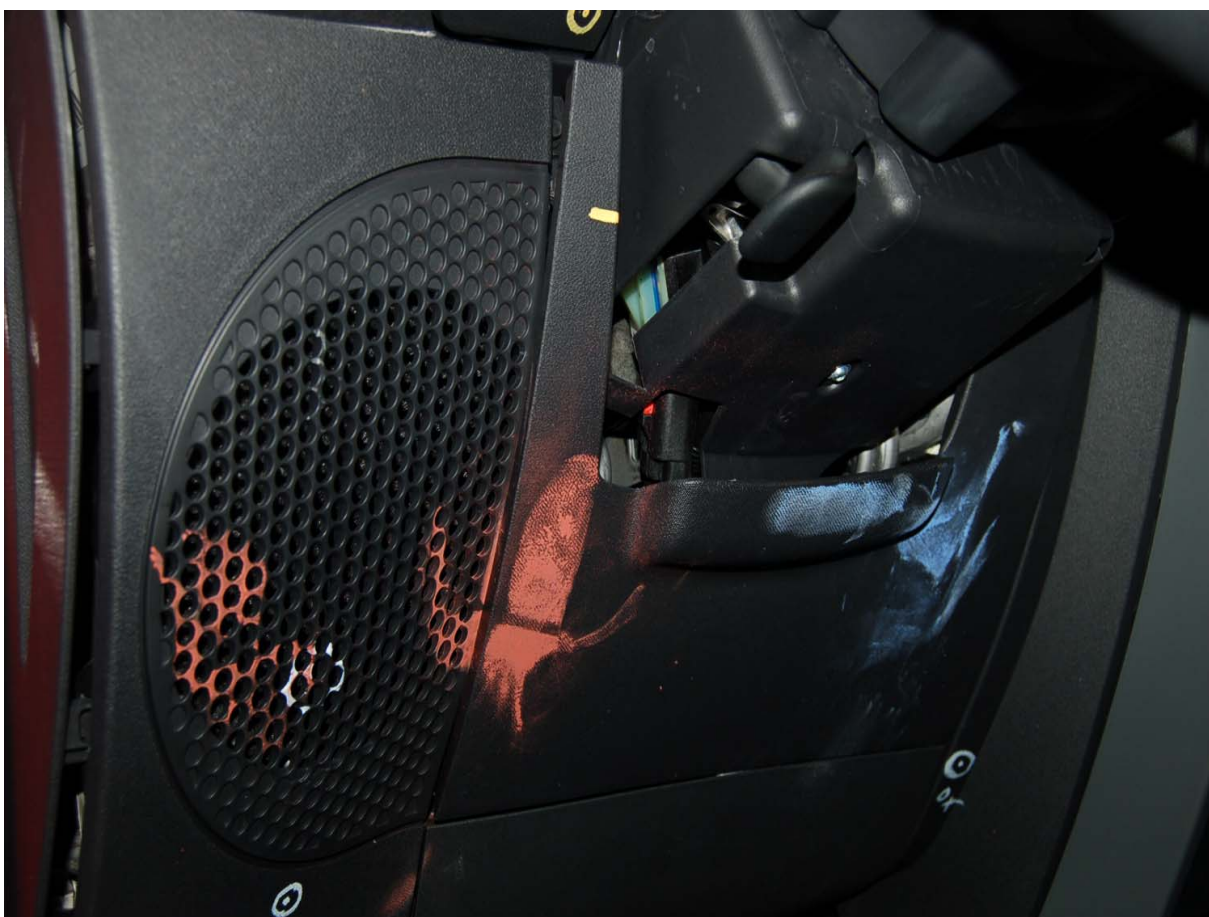
Post-Test Driver Dummy Knee Contact

The driver's head and chest contacted the airbag. The driver's head also contacted the headrest. The driver's knees contacted the bolster. The passenger's head and chest contacted the airbag. The passenger's head also contacted the headrest. The passenger's knees contacted the glove box.

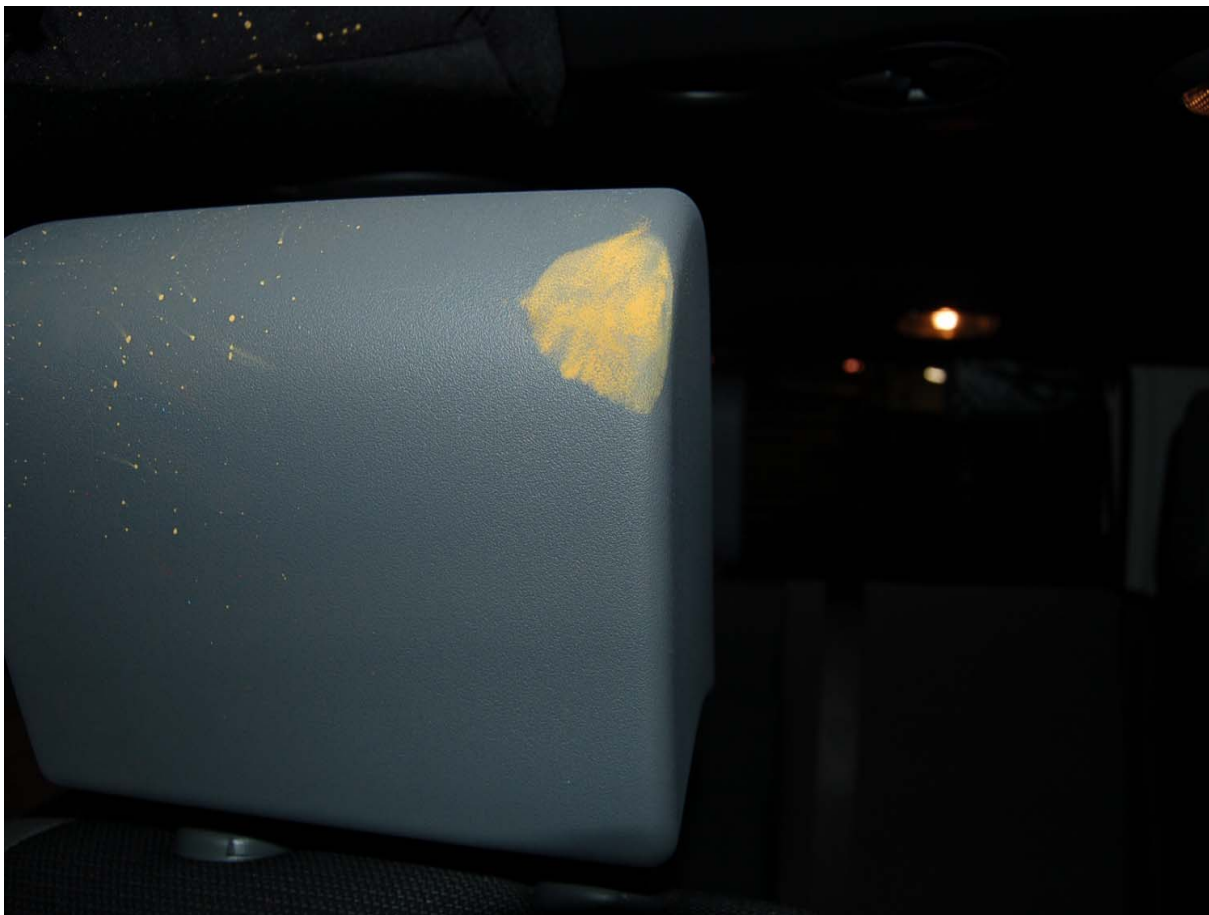
Post-Test Passenger Dummy Head Contact (headrest)

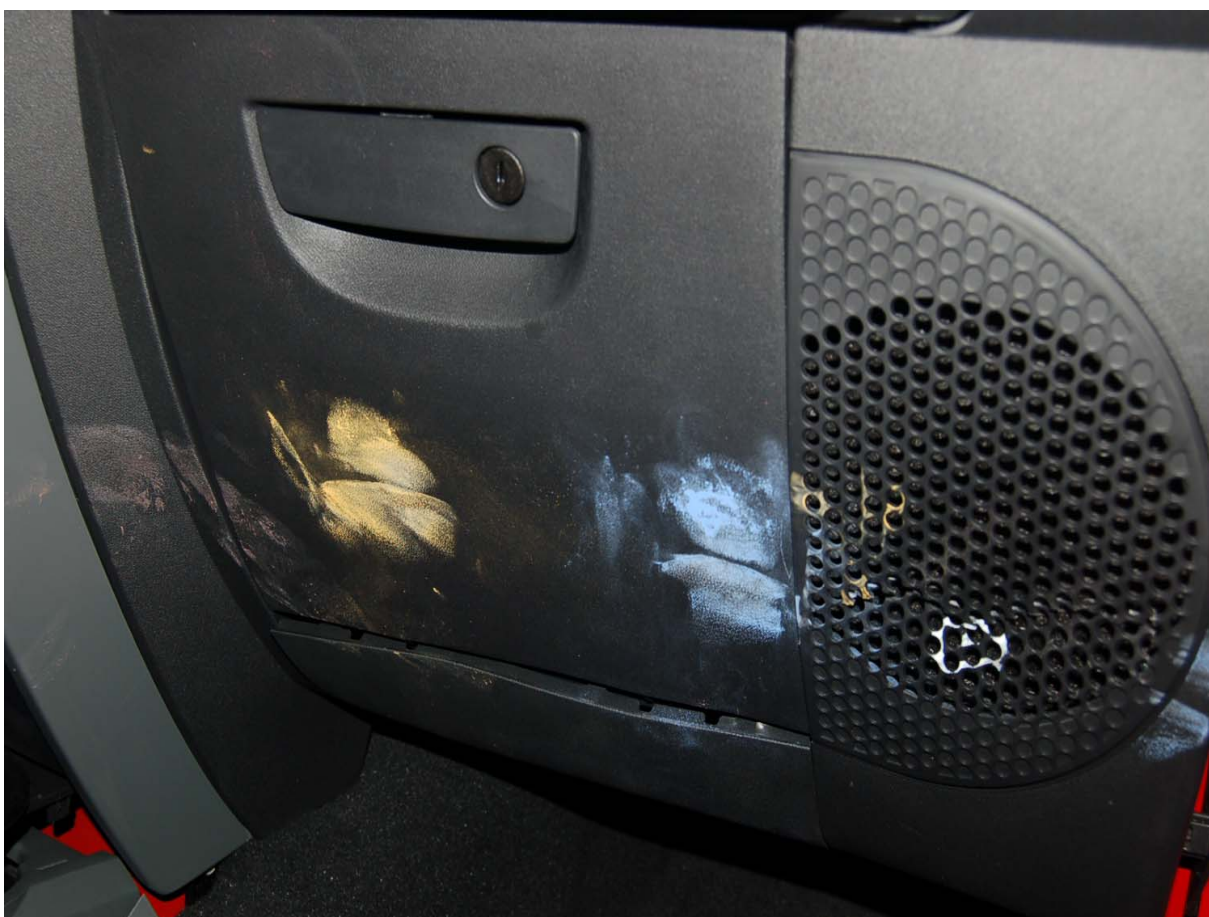
Post-Test Passenger Dummy Knee Contact

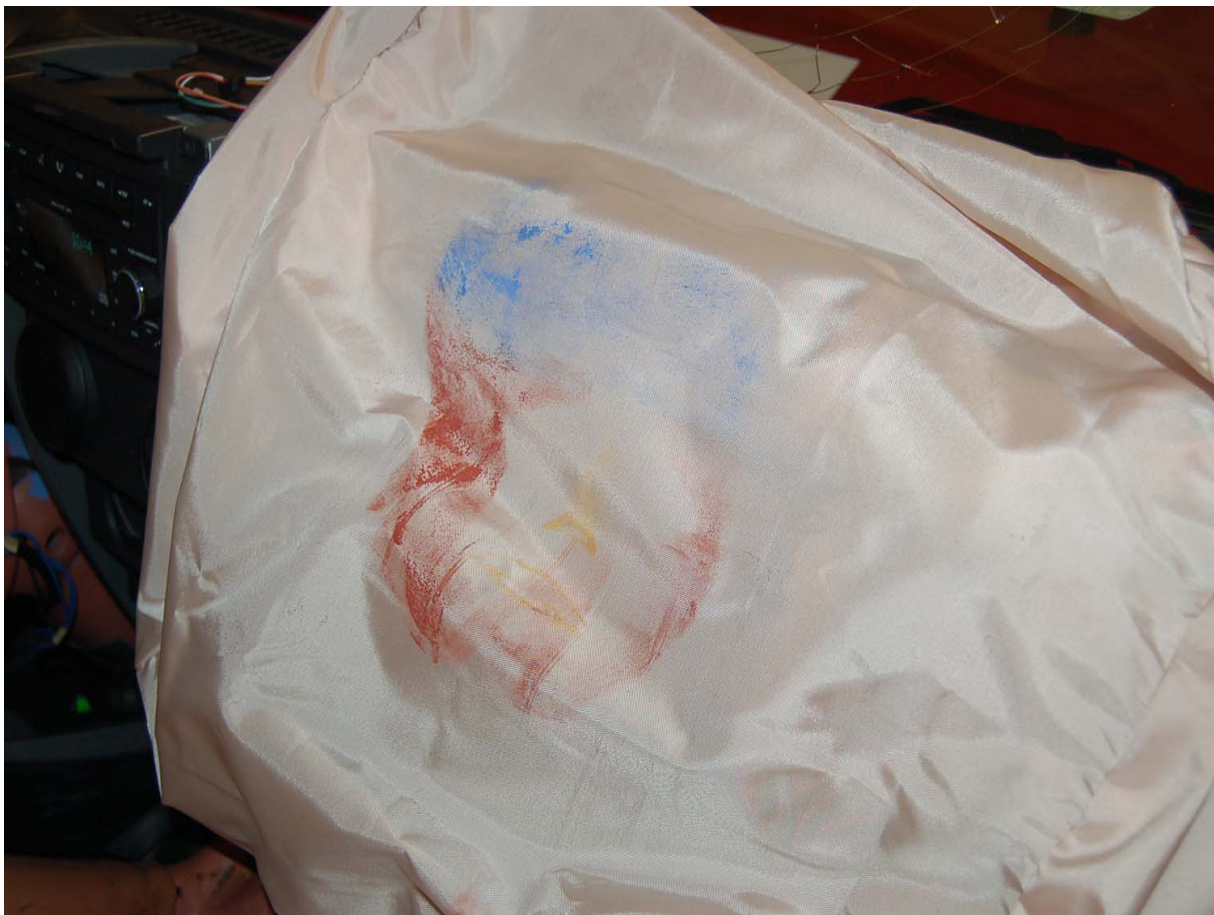
Post-Test Passenger Dummy Airbag Contact

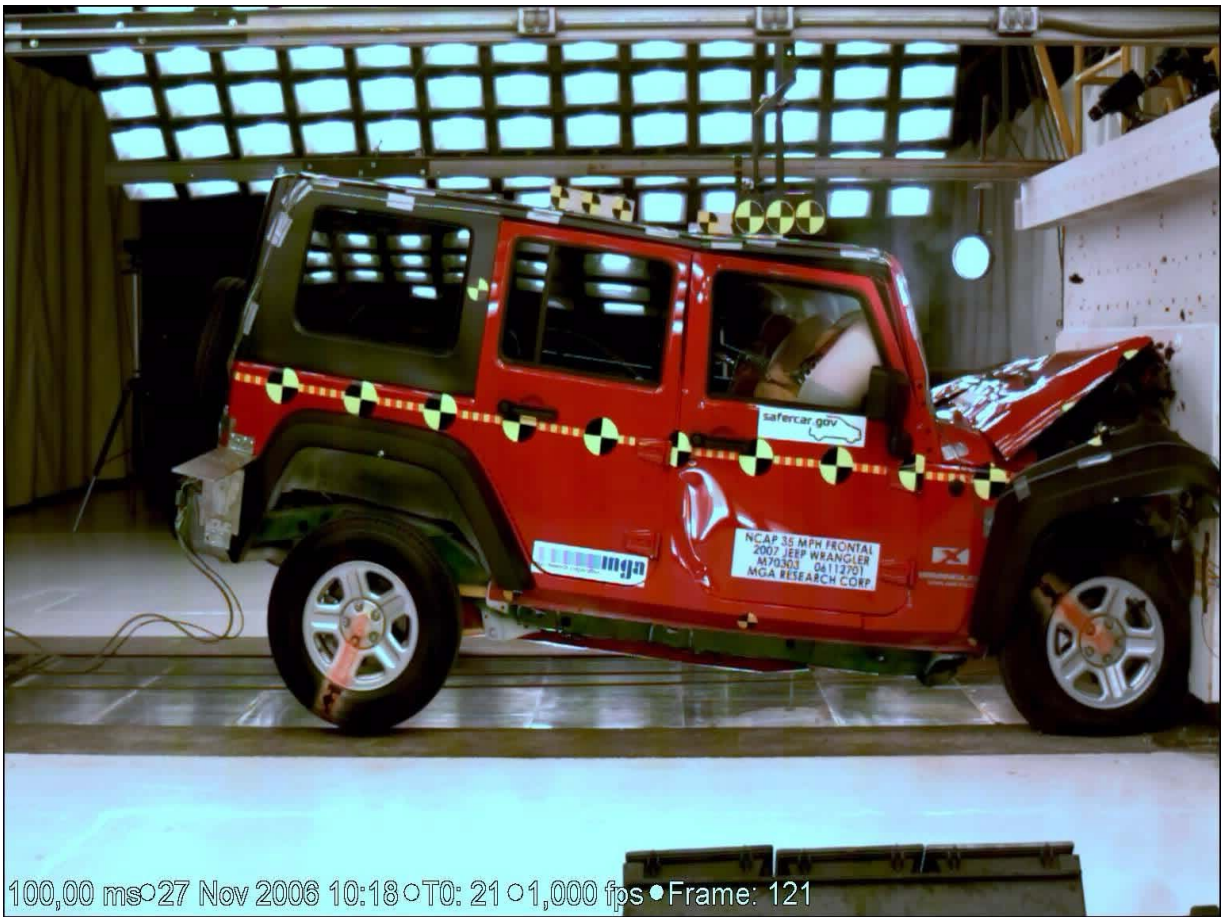
100,00 ms 27 Nov 2006 10:18 T0: 21 1,000 fps Frame: 121

Vehicle Impact

A load cell barrier was impacted by a 2007 Jeep Wrangler at a velocity of 56.5 kph. The test was performed at MGA Research Corporation on November 27, 2006. Pre-and post-test photographs of the vehicle and dummies can be found in Appendix A.
